Development and Proof Services

Report No. DPS/TW-403/5

JULY 1959

Aberdeen Proving Ground
Maryland

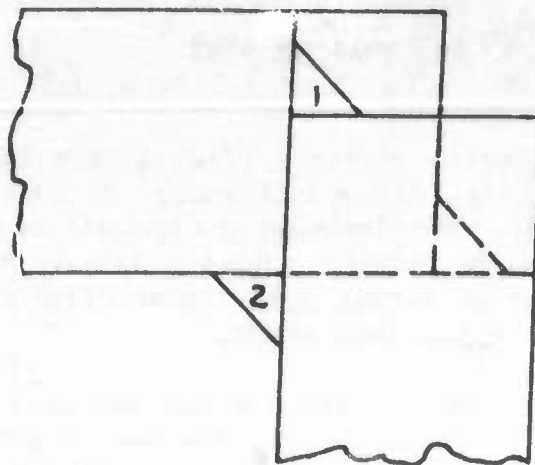
Fig 3

The T113 was designed with two different types of welded joints employed between the upper hull side plate and the upper glacis plate and hull roof plate. An interlocking or "dove tail" incomplete-weld-penetration joint was used on the right side of the hull (Fig. 3). In a joint of this type each plate of the joint is alternately recessed or notched to a predetermined distance so that when the two plates are brought together and joined by a continuous weld pass a true interlocking design is achieved.

Figure 3: Cross Sectional View of a Typical Interlocking Joint.

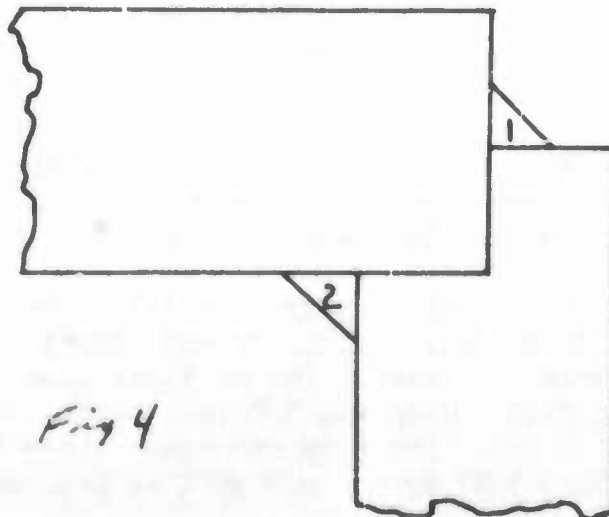
Fig 4

On the left side of the hull a rebated-type incomplete-weld-penetration joint was used.

Figure 4: Cross Sectional View of a Typical Rebated Joint.

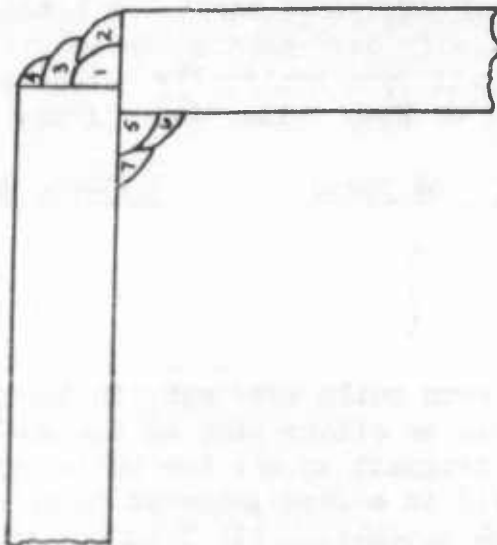
The T117 vehicle was fabricated from a rolled homogeneous steel armor of a modified hardness. The main armor of this hull was of 1/2-inch thickness except for a 5/8-inch-thick vertical front nose plate, a 3/16-inch-thick main floor plate and a 3/8-inch-thick lower hull side plate. This hull was designed with all conventional incomplete-weld-penetration joints (Fig. 5).

Figure 5: Cross Sectional View of Conventional Incomplete-Weld-Penetration Joint.
